Site Description

Date of Inspection: October-29-21		Licence/Permit Number: 602642	
Licensee/Permittee Name: THE CORPORATION OF THE TOWNSHIP OF ZORRA			
Site Name: ROBINSON PIT			
Address: 274620 27TH LINE P.O. BOX 306, INGERSOLL		E-Mail Address: soliver@zorra.on.ca	
Lot(s): PT OF LOT 29	Conc.(s): 1	Township: ZORRA	
Local Municipality: ZORRA TP	Mining Claim #:		
County/Region: OXFORD CO	UTM# (NAD 83):		
Licence/Permit Area (ha): 37.03	Extraction Area (ha):		18.92
Inspection Category: Follow-up	Authority Type:		Class A Licence
Operation Type: Pit	Operating Status:		Operating
Above Water: Yes

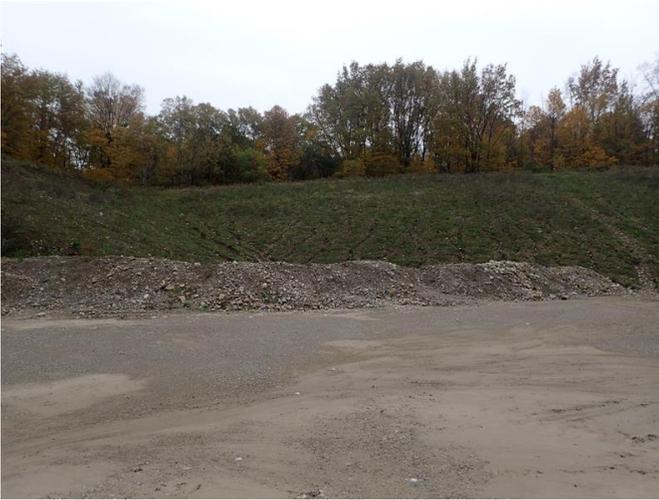
TG-4; PA290048.JPG

Rehabilitation slopes in the SW corner of Area 1 have been established

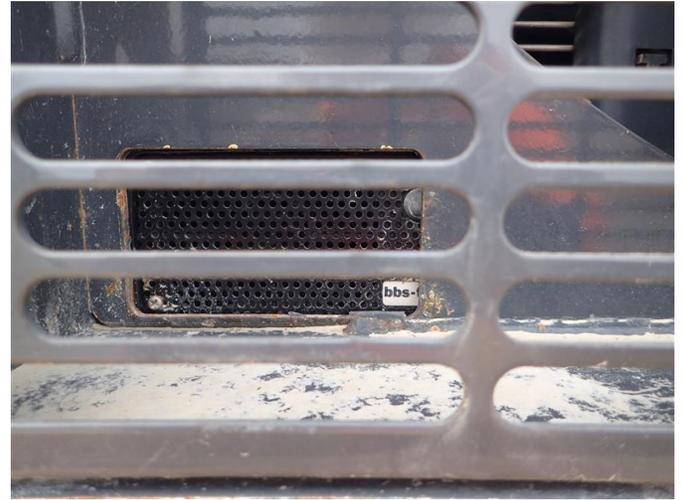
TG-4; PA290049.JPG

"Quiet" back-up alarm installed at the back end of John Deere Loader

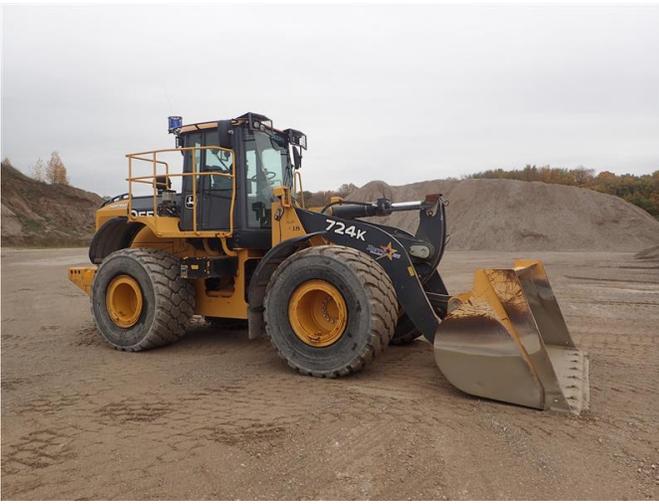
TG-4; PA290050.JPG

John Deere loader with "Quiet" back-up beeper on the pit floor in Area 1

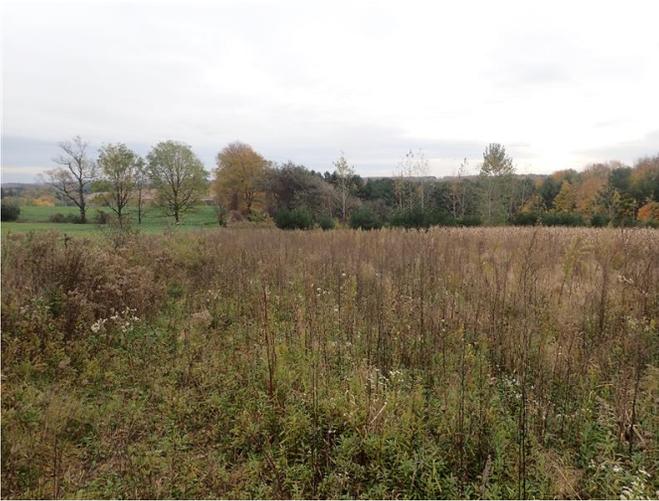
TG-4; PA290053.JPG

View N along the wildlife corridor between woodlot 1B and the E boundary of the licence; Bushes and small trees were observed amongst the weeds

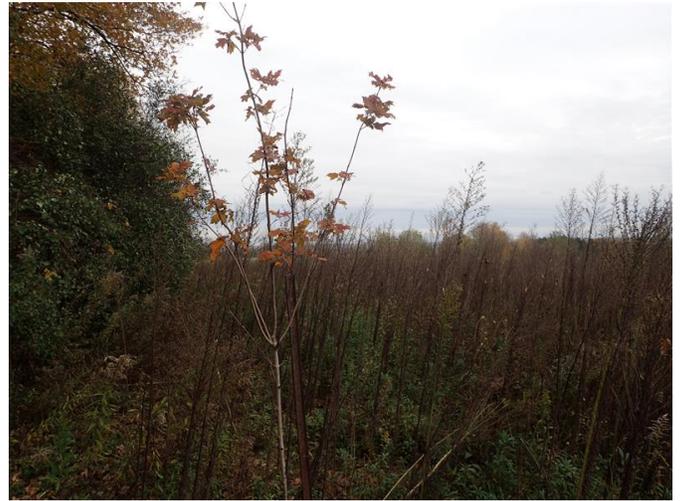
TG-4; PA290054.JPG

View N along the 10 m wide wildlife corridor along the E side of woodlot 1B; Two staggered rows of >2m tall trees are planted in this area.

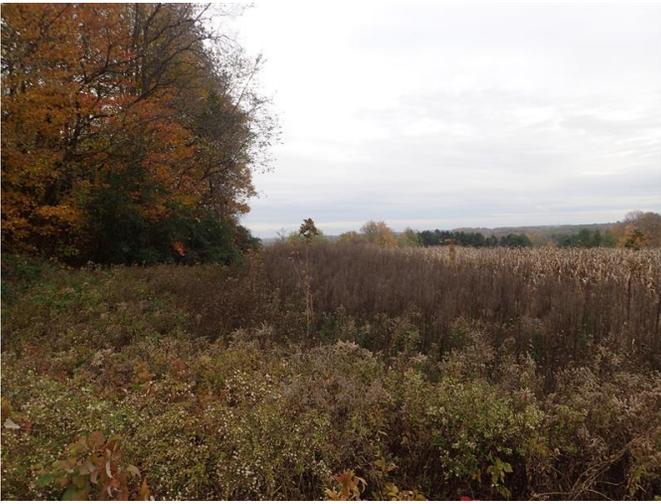
TG-4; PA290055.JPG

View NE along the 10 m wide wildlife corridor along the SE side of woodlot 1B; Two staggered rows of >2m tall trees are planted in this area.

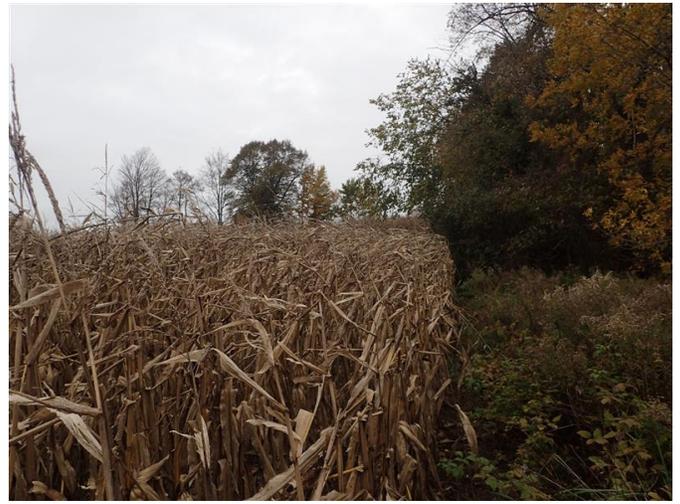
TG-4; PA290056.JPG

View N along the 10 m wide wildlife corridor along the W side of woodlot 1B; Corn remains in place in this area.

Item	Section (Aggregate Resource Act / Provincial Standards)	Remedial Action Required	Remedial Action Date
Wildlife Corridor	Section 15 of the ARA; specifically Phase Notes and Diagrams on page 2 of the Site Plan and Natural Environment Recommendation 1.1, 1.1.4, and 1.6, and the Typical Section of 15 m Wildlife Corridor on page 3 of the Site Plan	Plant a mixture of native trees and shrubs, per notes on the site plan, within the 10 m buffer along the west side of Woodlot 1B located along the N boundary of the site	November-20-21
