Site Description

Date of Inspection: November-09-20		Licence/Permit Number: 602642	
Licensee/Permittee Name: THE CORPORATION OF THE TOWNSHIP OF ZORRA			
Site Name: ROBINSON PIT			
Address: 274620 27TH LINE P.O. BOX 306, INGERSOLL		E-Mail Address: soliver@zorra.on.ca	
Lot(s): PT OF LOT 29	Conc.(s): 1	Township: ZORRA	
Local Municipality: ZORRA TP	Mining Claim #:		
County/Region: OXFORD CO	UTM# (NAD 83):		
Licence/Permit Area (ha): 37.03	Extraction Area (ha):		18.92
Inspection Category: Follow-up	Authority Type:		Class A Licence
Operation Type: Pit	Operating Status:		Operating
Above Water: Yes

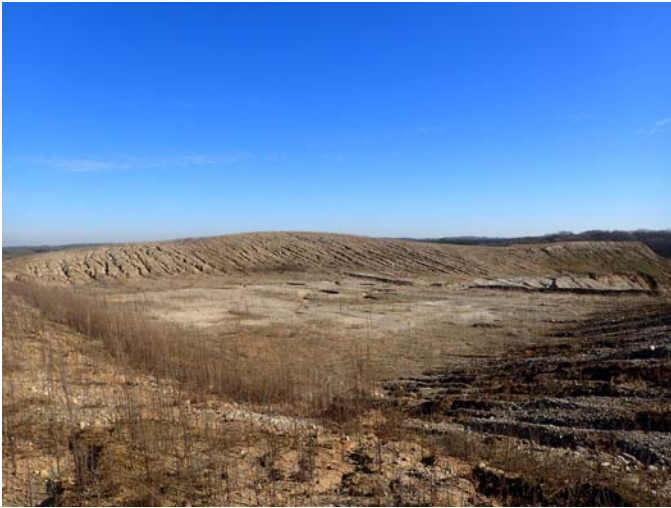
2020/11/09 13:44:38
TG-4;PB090110.JPEG
Taken by: Stephen Douglas
View E toward the N end of the Interim Berm
which has been graded and seeded

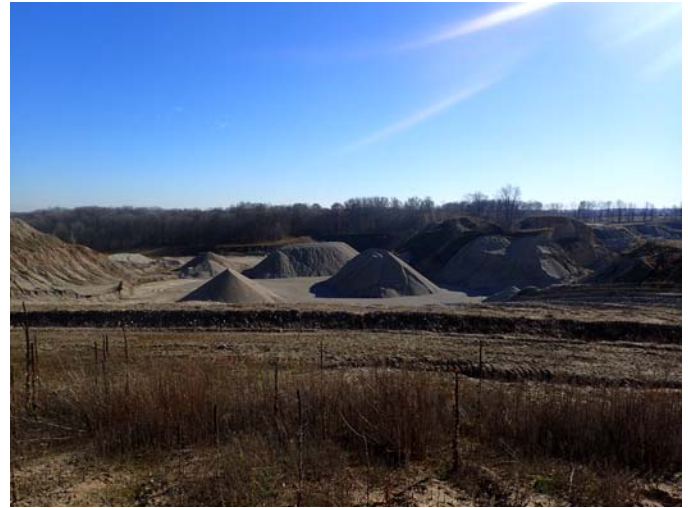
2020/11/09 13:46:55
TG-4;PB090112.JPEG
Taken by: Stephen Douglas
View S across extraction activities in Area 1

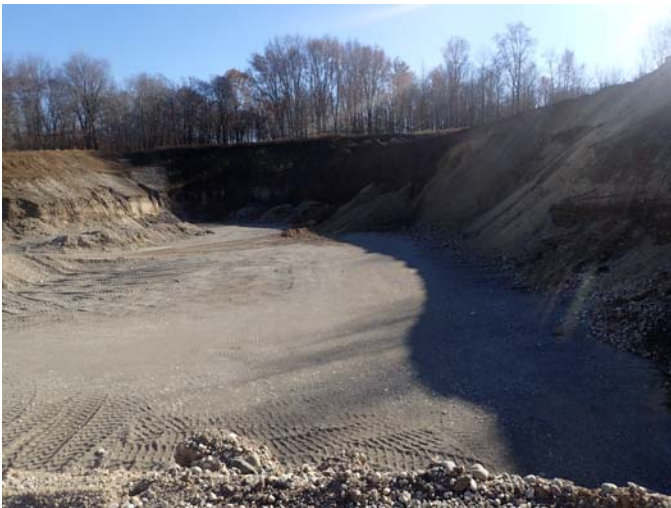
2020/11/09 13:54:07
TG-4;PB090115.JPEG
Taken by: Stephen Douglas
Extraction has gone to the deepest elevation in
the S part of Area 1

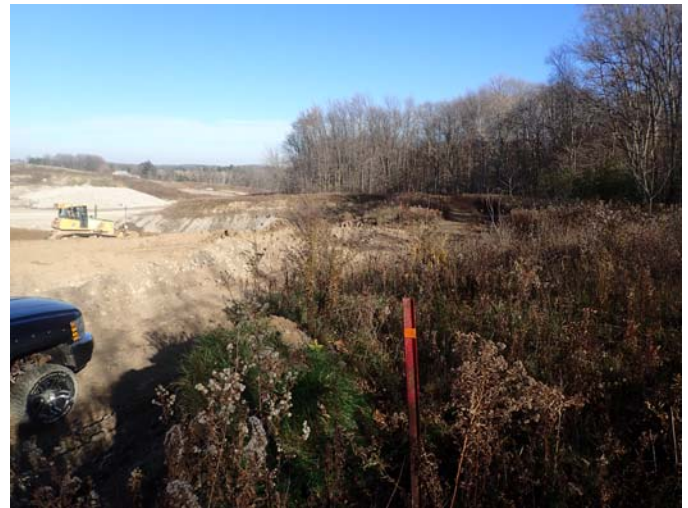
2020/11/09 13:59:50
TG-4;PB090116.JPEG
Taken by: Stephen Douglas
Setbacks along the woodlot that occurs along
the S part of the site is well-marked with
red-painted t-bar posts

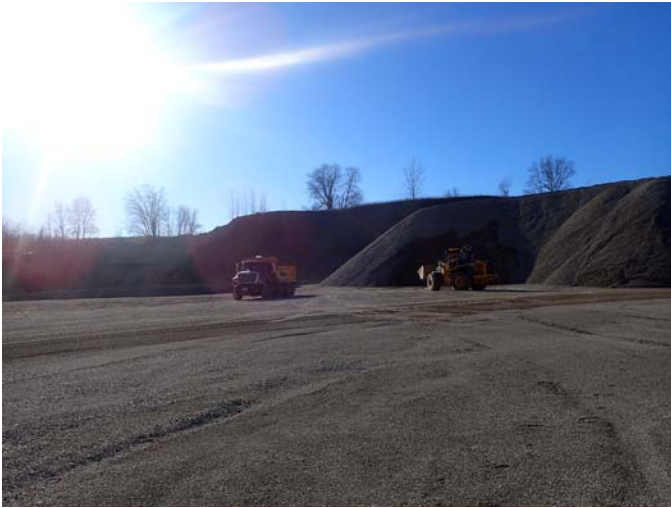
2020/11/09 14:16:31
TG-4;PB090118.JPEG
Taken by: Stephen Douglas
Loading of a dump truck in the S part of Area 1

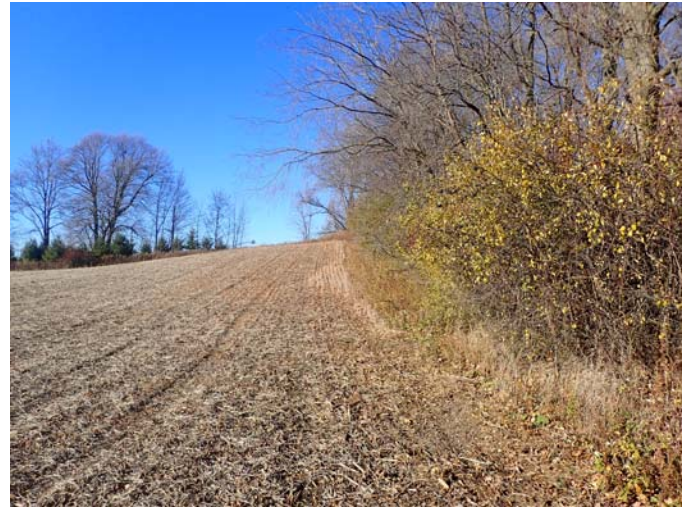
2020/11/09 14:36:06
TG-4;PB090119.JPEG
Taken by: Stephen Douglas
View N along the 10 m buffer to the woodlot located in the N part of Area 2; No trees have been planted in the buffer area

Item	Section (Aggregate Resource Act / Provincial Standards)	Remedial Action Required	Remedial Action Date
Back-Up Warning Devices	Section 15 of the ARA; specifically Note 25 on page 2 of the Site Plan	Install alternate back-up warning devices on mobile production/ shipping equipment operating in the pit	January-30-21
Wildlife Corridor	Section 15 of the ARA; specifically Phase Notes and Diagrams on page 2 of the Site Plan and Natural Environment Recommendation 1.1, 1.1.4, and 1.6, and the Typical Section of 15 m Wildlife Corridor on page 3 of the Site Plan	Plant a mixture of native trees and shrubs, per notes on the site plan, within the 10 m buffer along the east, south and west sides of Woodlot 1B located along the N boundary of the site	November-20-21

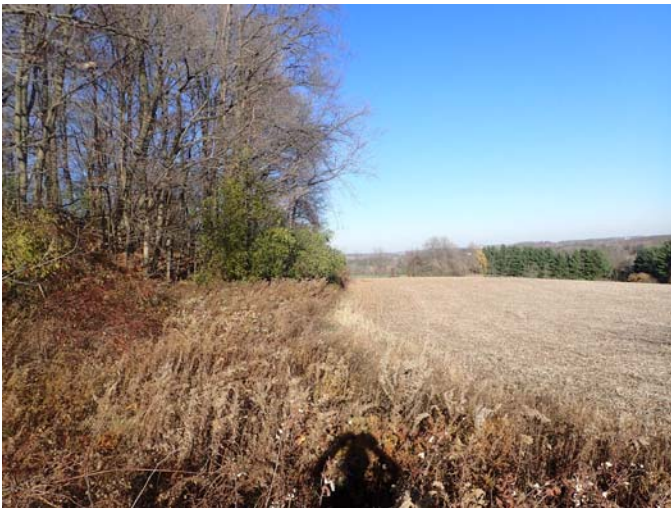
2020/11/09 14:36:21
TG-4;PB090120.JPEG
Taken by: Stephen Douglas
View E along the 10 m buffer to the woodlot located in the N part of Area 2; No trees have been planted in the buffer area

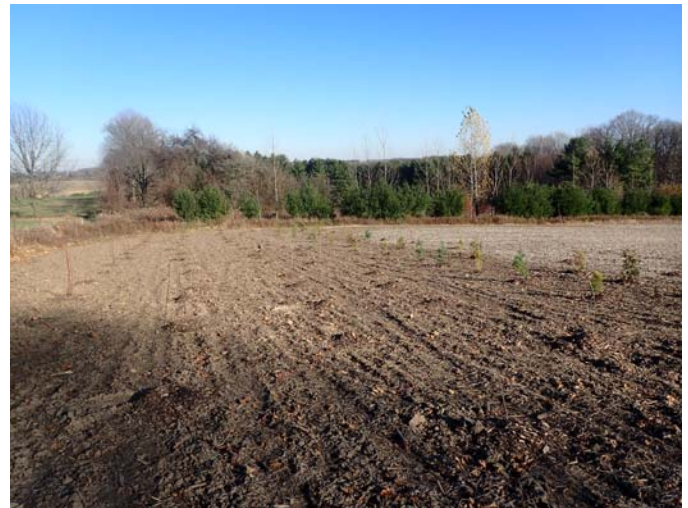
2020/11/09 14:38:51
TG-4;PB090121.JPEG
Taken by: Stephen Douglas
View E along the N boundary 15 m setback which has recently been planted with trees to establish a Natural Wildlife Corridor
