# Geotechnical Engineering Report

Slope Stability Assessment

Proposed Harrington Pit

Final Report

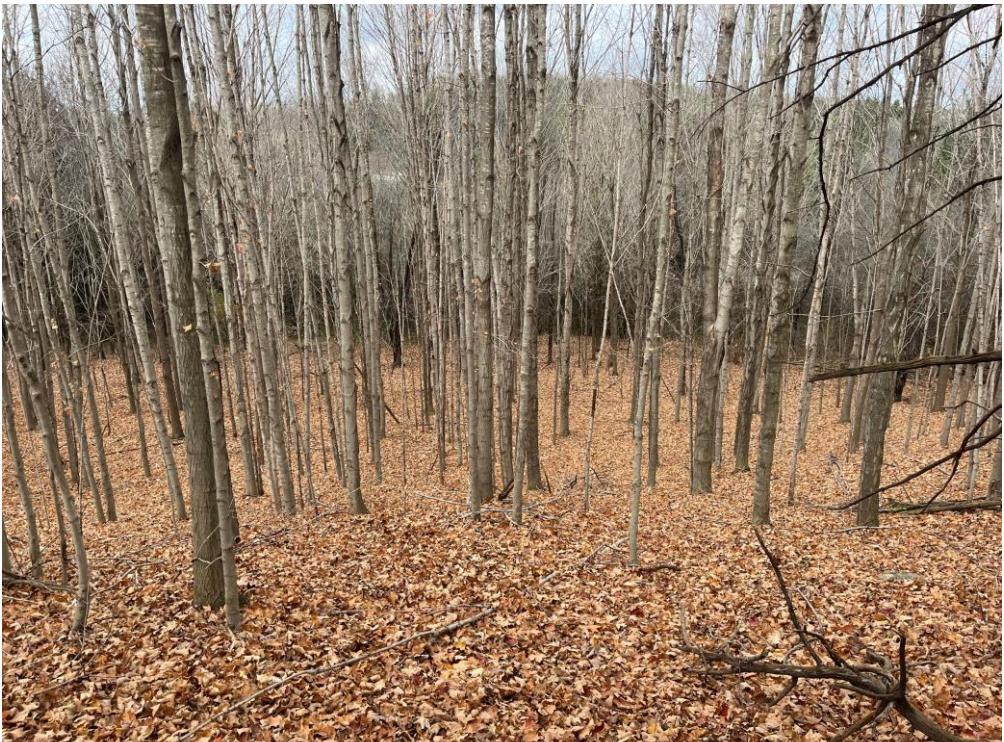
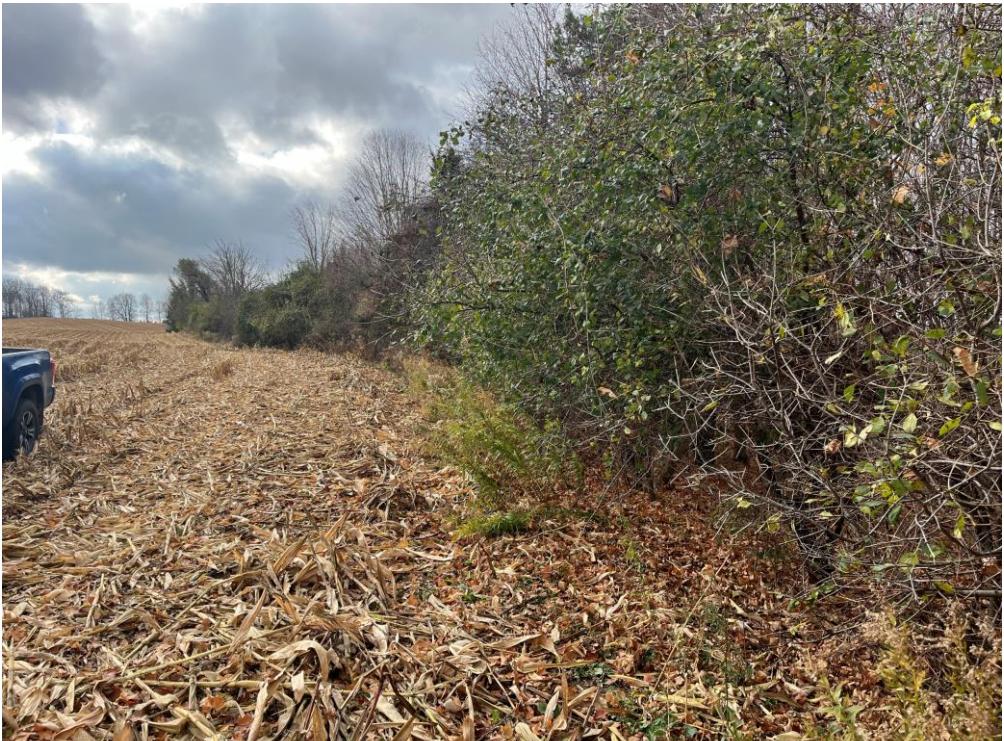
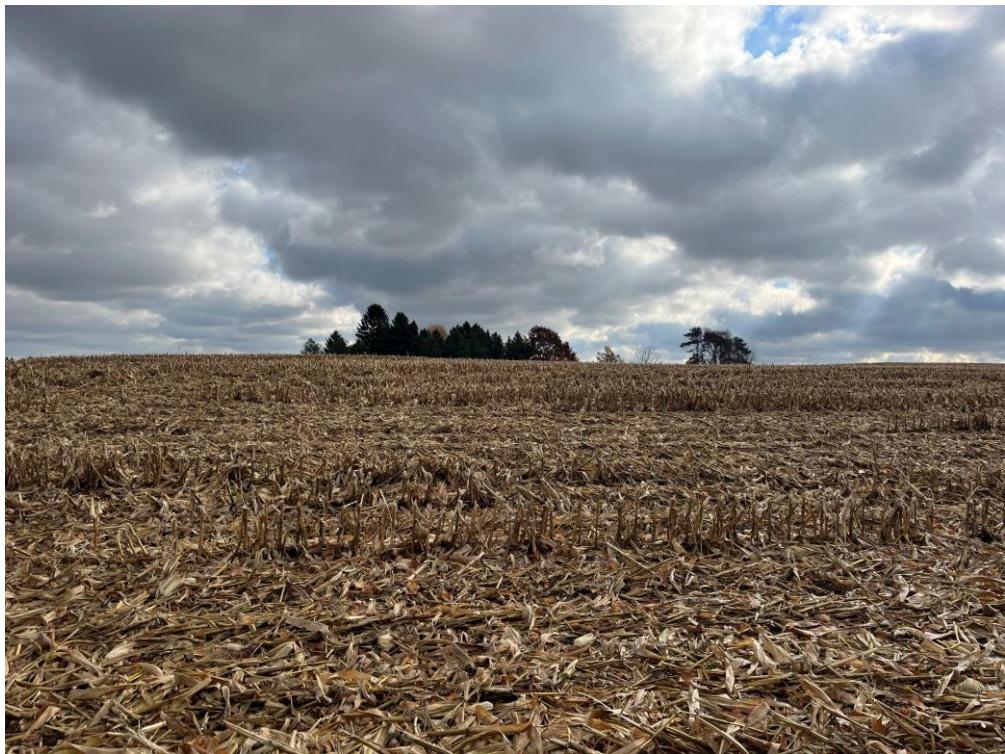
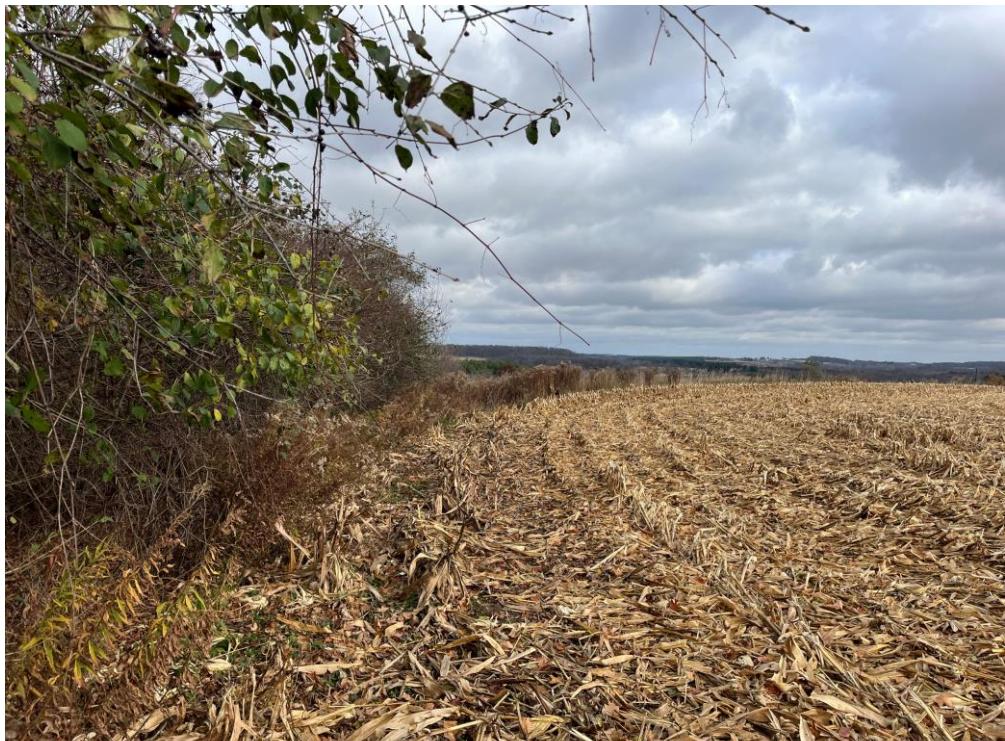
# Slope Stability Analyses

The above soil strength parameters were based on effective stress analysis for long-term slope stability. Graphical depictions of the slope stability analysis results are presented in Appendix E. Based on the results of the analyses; it is our opinion that the slopes will remain stable under long-term condition after excavation and a height reduction of 10 m, provided that the excavation sides are sloped at 3H:1V or gentler. Drawings 2 and 3 in Appendix A present the cross-sections and relevant details of the cross-sections analyzed for determination of the stability of slopes. Based on the results of the analyses, the proposed slope of 3H:1V will be stable and the vegetation cover is needed to protect it against erosion. Considering the drawings and the cross section sent by the client, the proposed excavation works are estimated to be around 660,000 m<sup>3</sup> and can be safely constructed without adversely affecting the long-term stability of the slopes.
