**RE: Aggregate Resources Act Application – Proposed Harrington Pit
Comments Provided by Dr. Larry Jensen, November 8, 2024**

This letter provides information and analysis to respond to groundwater related comments provided by Dr. Larry Jensen in his email package directed to Harrington McAvan Ltd , ARA Approvals and, MNR hydrogeologist (Oleg Ivanov), dated November 8, 2024.

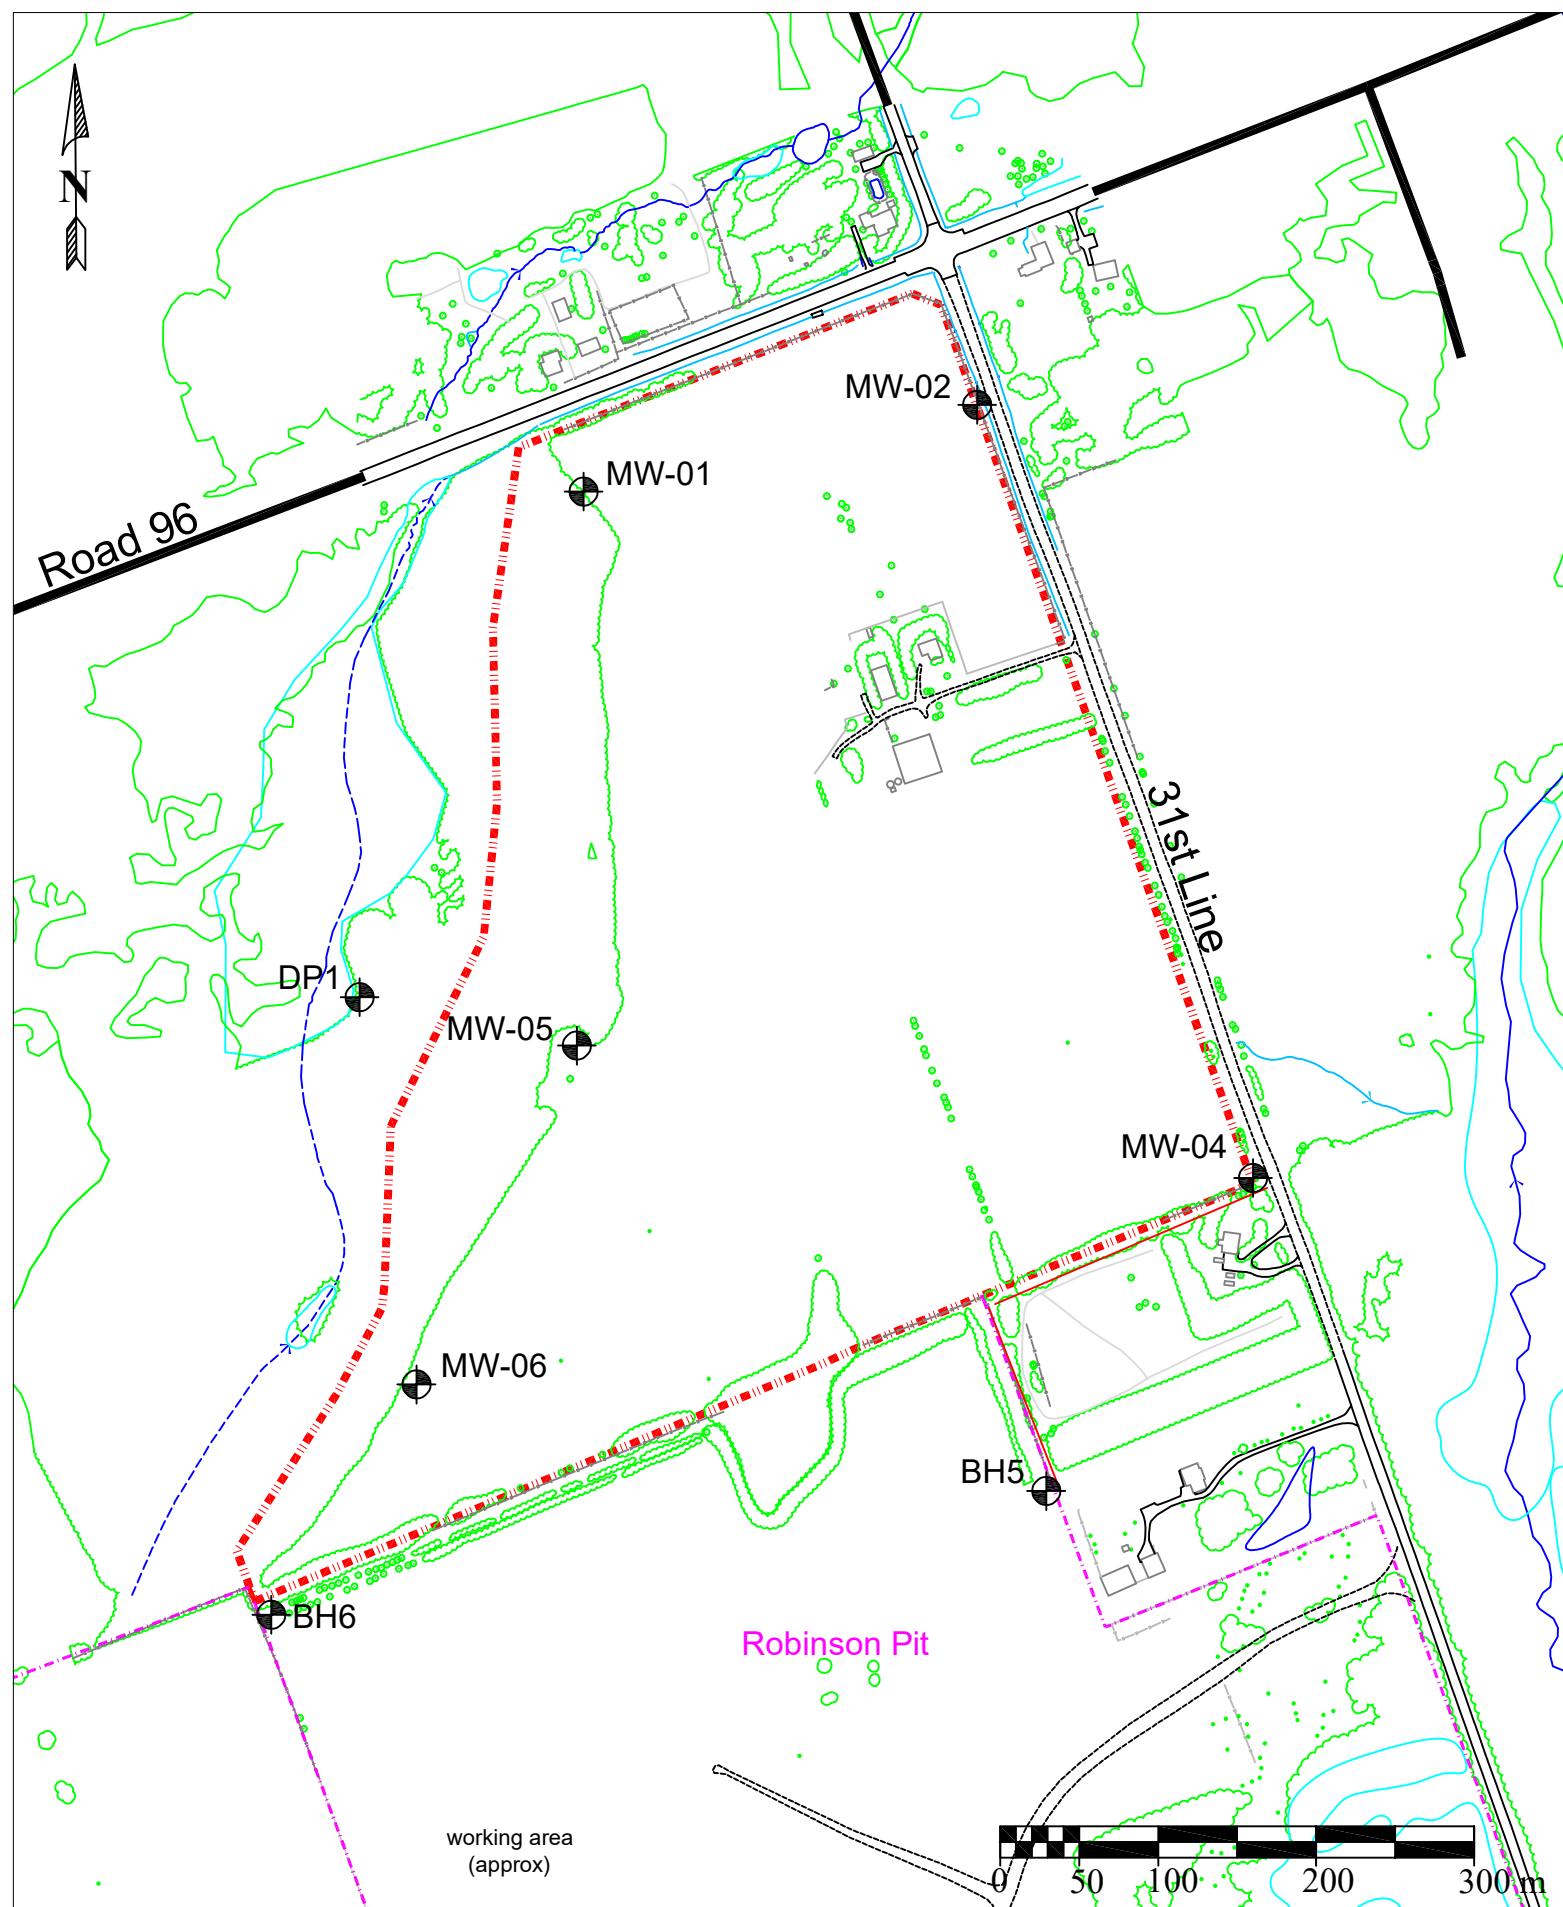
The new monitoring well locations, referenced as MW-05 and MW-06, are shown on the attached figure. The wells were drilled by SD Hopper Drilling using the reverse (air) rotary method, which is typically used for water supply or geothermal well installations. This method was chosen to overcome the difficult drilling conditions (interpreted presence of boulders at depth) encountered with previous environmental (hollow stem auger) drilling programs.

Attached: Figure 1: Drilling Locations
 Borehole Logs – MW-05 and MW-06
 Figure 2: Projected High Water Table

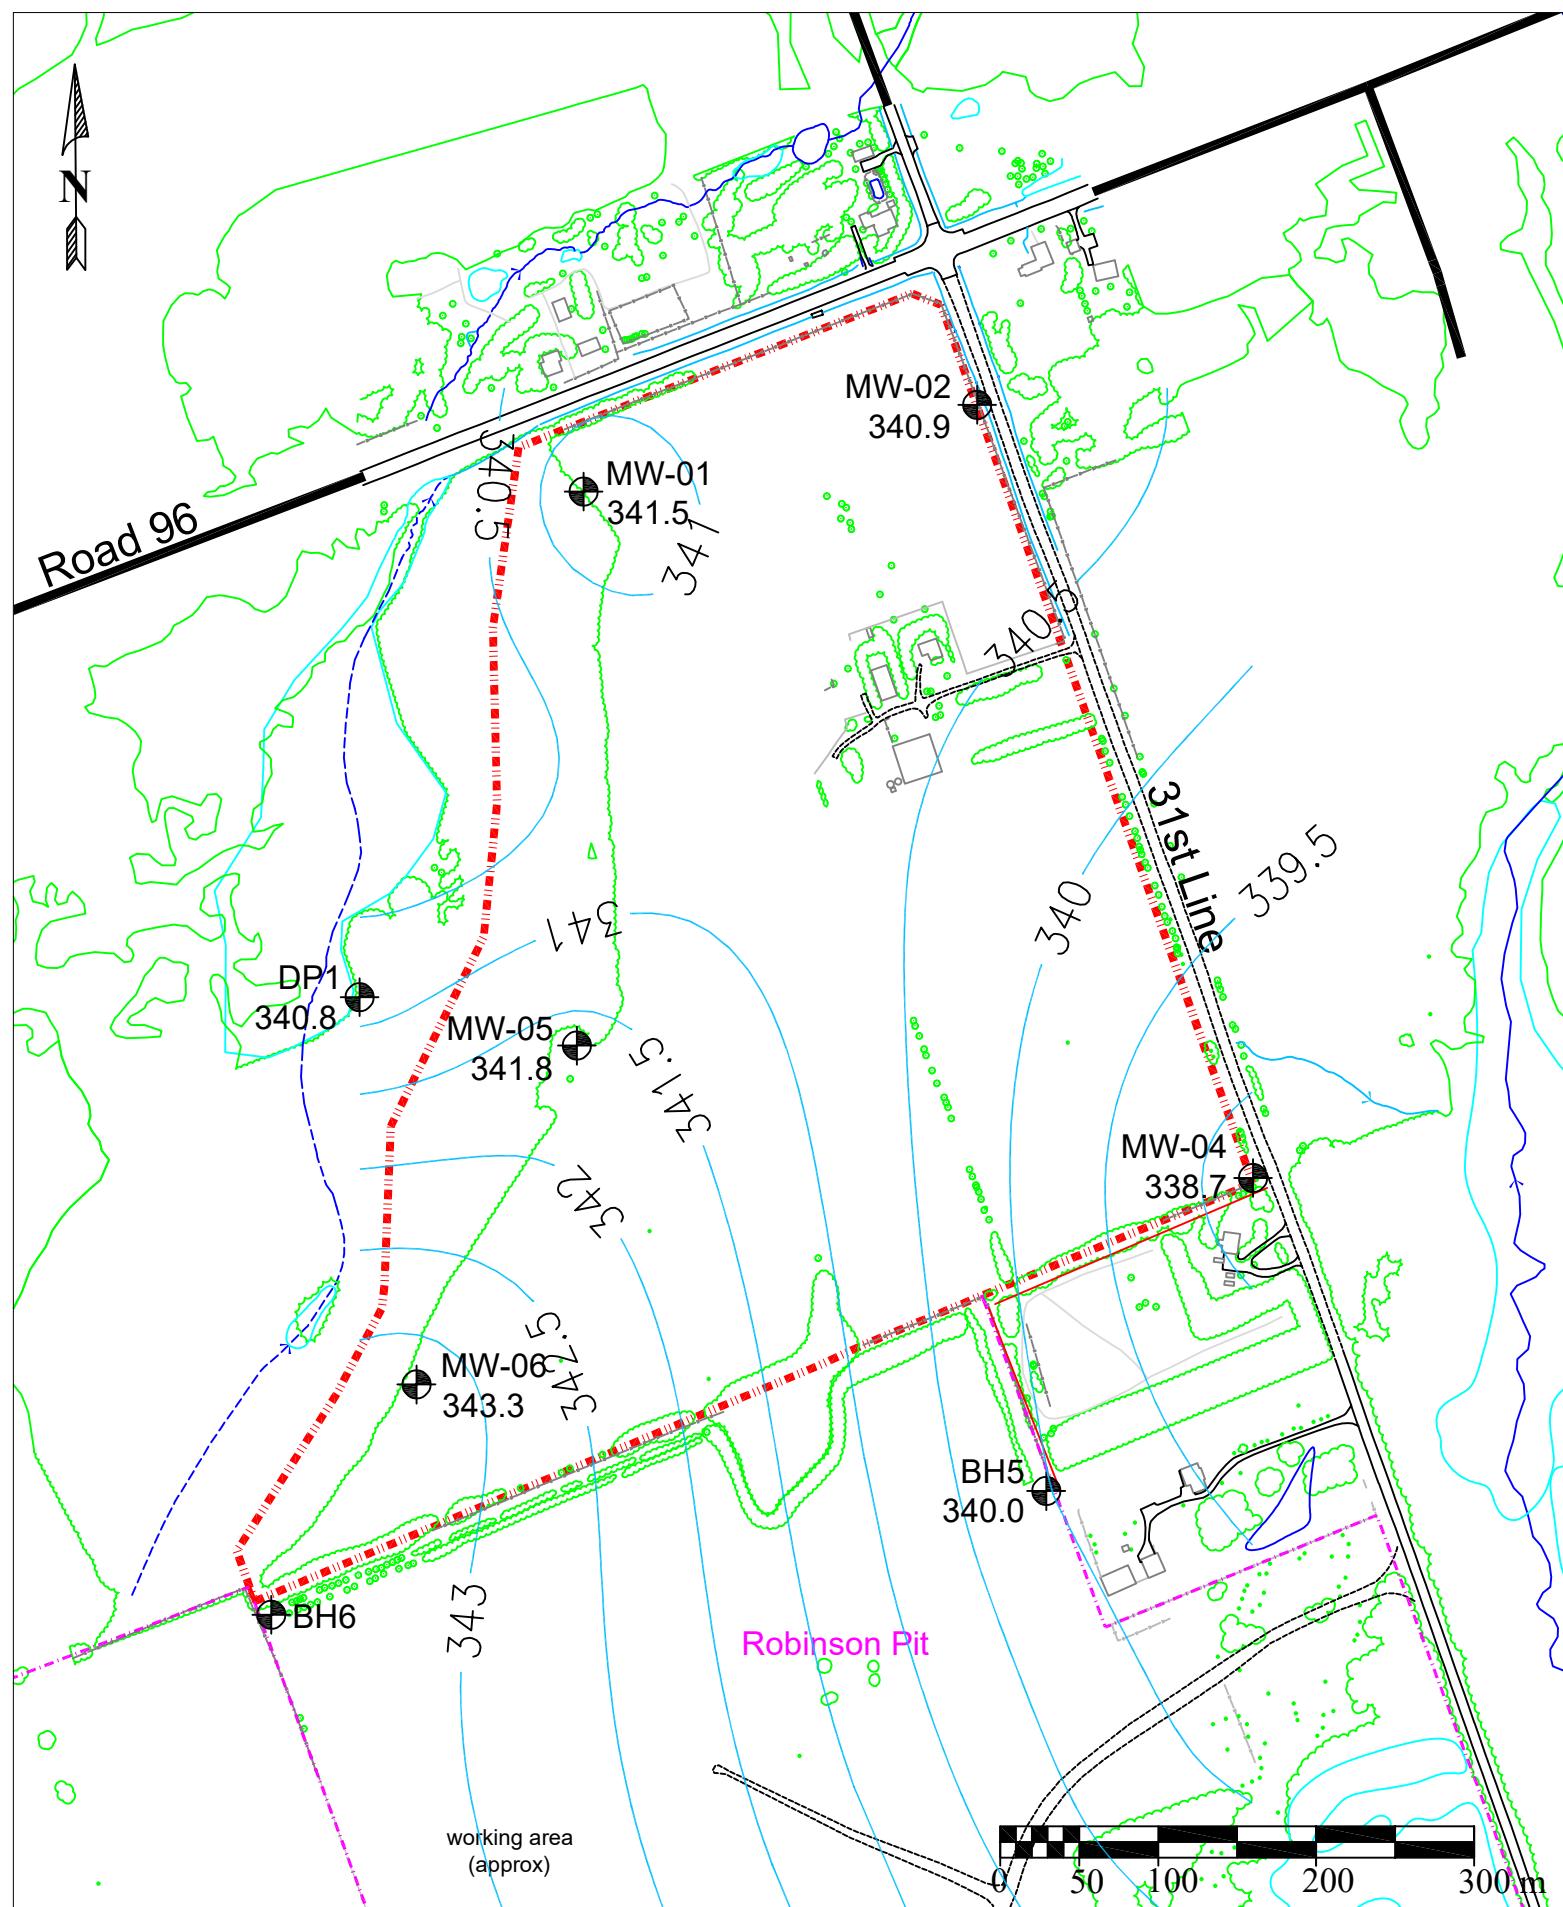
Figure 2: Projected High Water Table

Based on the new monitoring wells and monitoring completed to date a revised high water table projection is now available, as shown on the attached figure. This projection no longer relies on estimated water table elevations at the southwest corner of the site (water table elevation measurements in that area are now available) and is considered representative of observed site conditions.

----- Site (approx.)
----- existing licensed pits (approx)
● monitor, reference, high water table elevation
----- vegetation lines, wetlands, water bodies & watercourses, roads, etc. as shown

The number and distribution of monitoring locations at the site is sufficient to both establish water table conditions within the proposed extraction area and characterize the local groundwater flow system. The proposed extraction and rehabilitation plan has been revised to reflect the updated water table projection, and ensure that the extraction will remain 1.5 m or more above the projected water table.
